# Conditions Assessment

General George Stannard House  
Milton, Vermont

May 27, 2014

Scott Newman M.Sc.  
106 Associates

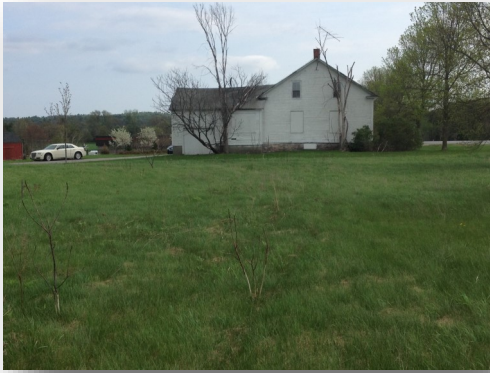
The eaves-front house measures 35 ft x 28 ft (eaves/gable) and is set back 35 ft from RT 7 on level ground. Drainage is presently an issue because of several excavations against the foundation that were not filled in, presumably from a previous inspection. Drainage could be improved by filling the voids and regarding to achieve positive drainage to achieve positive slope away from the building.

Photo left shows the building sited slightly elevated on level ground with ample room around it. It is anticipated that the site can be re-graded for drainage without need for a curtain drain or other extra measures.

- 1) fill voids and re-grade to allow positive drainage away from the structure.  
Allow \$ 1000

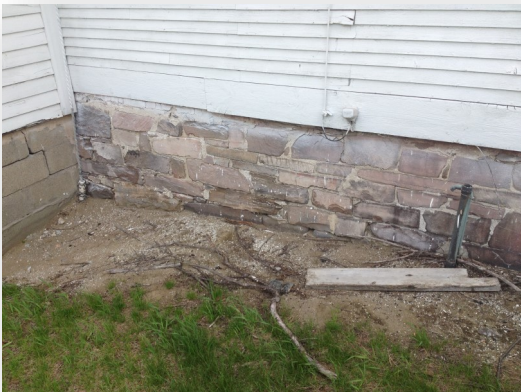
The condition of the foundation is generally good, as shown left, which was good news. Here the stone is well mortared with a soft lime mix.

- 1) Retain and repair foundation. Repoint brick and stone as required. Ensure use of soft, compatible mortar suitable for use with the old bricks. Repair or pour concrete wall in place of bulkhead entrance to basement.  
Allow \$4000 in Phase 1

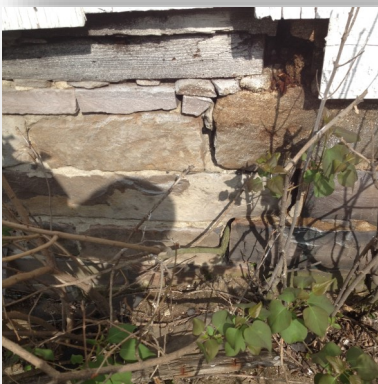
In some areas the foundation need to be reset, Branches are growing in and through the wall in some places, and stones are loose and need to be pointed.

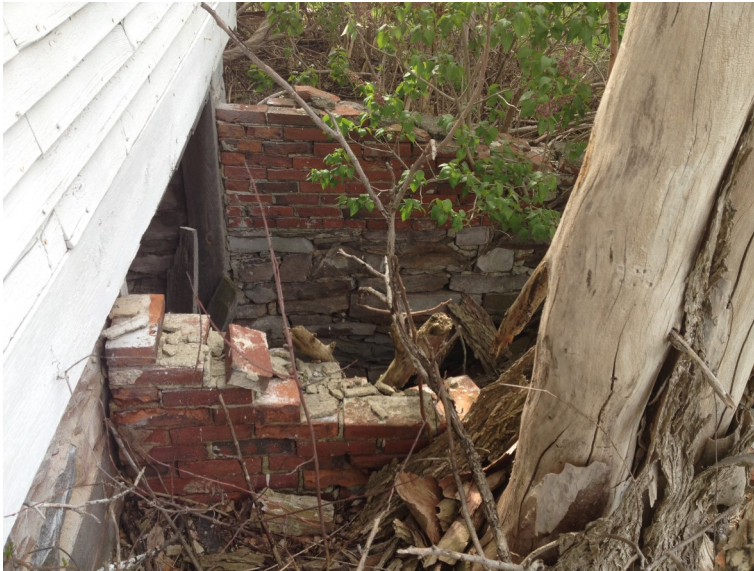
The bulkhead shown left has been open to the weather for an undetermined period. Trees and shrubs growing adjacent have dislodged the bricks. They will need to be removed and the bulkhead will need to be repaired or removed.

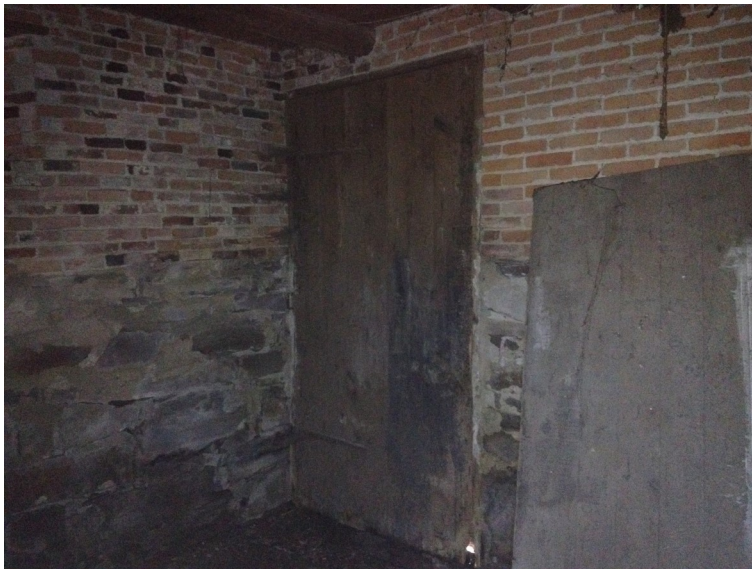
Photo shows lower mortared stone with brick extending above grade in good condition. This and other evidence including a 9 ft ceiling height suggests the building was raised 35 inches.

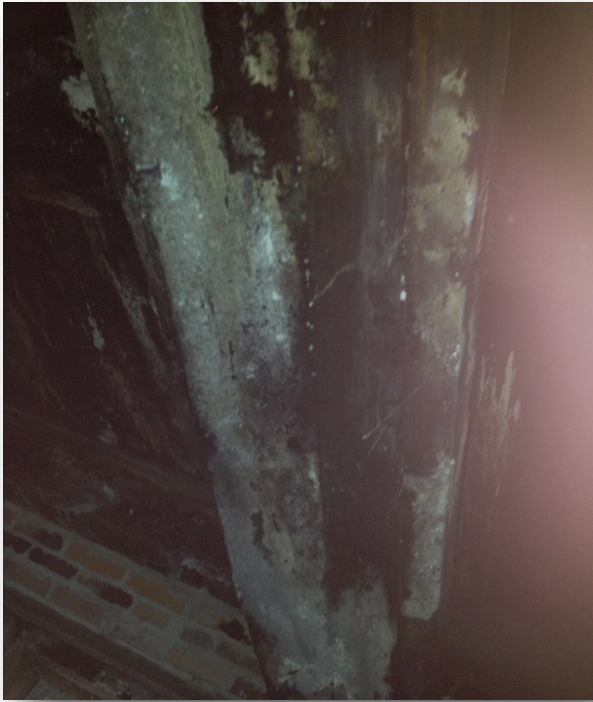
As observed in the basement, much of the framing is water-stained with organic material growing on it. This is due to water leaking through the roof and down through the building floors into the basement. The material should be tested to decide on a course of action, but many molds can be cleaned from wood and do not present an ongoing issue. Though the accessible wood “sounded” free passed the screwdriver test, a more detailed inspection will be needed once interior demolition is complete.

- 1) Inspect framing for damage and rot once exposed after interior demolition.
- 2) Replace or reinforce damaged framing to ensure the building is stable. Anticipate 50% sill replacement. Cross bracing will likely be required after the interior lath is removed.
- 3) Test for presence and type of mold on framing and remediate as needed.  
Allow \$ 6,000 in Phase 1.

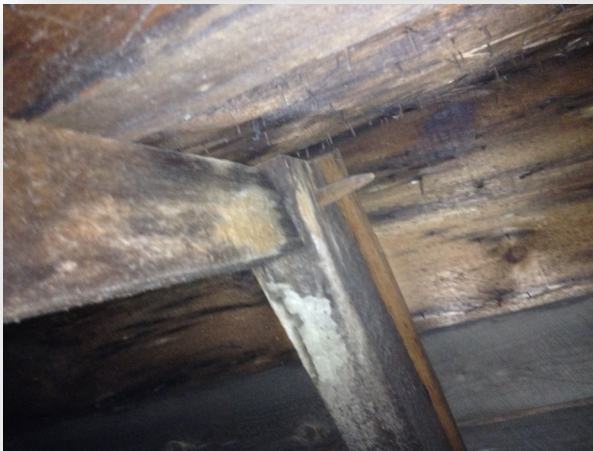
Rafters are original 4"x4", pegged at the ridge. Due to ongoing water infiltration they are also stained with the presence of organic material. Some rotting wood was observed at the peak and will require further inspection once it is exposed.

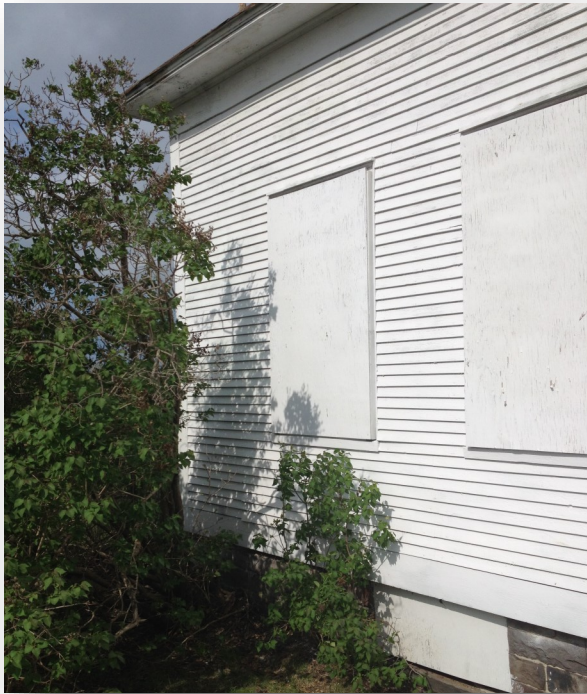
This is a Phase 2 Item. Like the foundation, exterior woodwork was observed to be in better than expected condition thanks to the attention given it by the Milton Historical Society who painted the building and covered the windows. There is damage to the soffit due to roof leaks, but much of the siding can be simply painted. The skirt board seen at the bottom of the siding in the left photo overhangs the stone foundation by some 3 inches which has further limited deterioration. This is all very good news for character-defining features, and the budget.

- 1) Repair and/or replace damaged woodwork in-kind
- 2) Refasten, re-nail loose siding
- 3) Reconstruct entry porch
- 4) Reconstruct back stairs

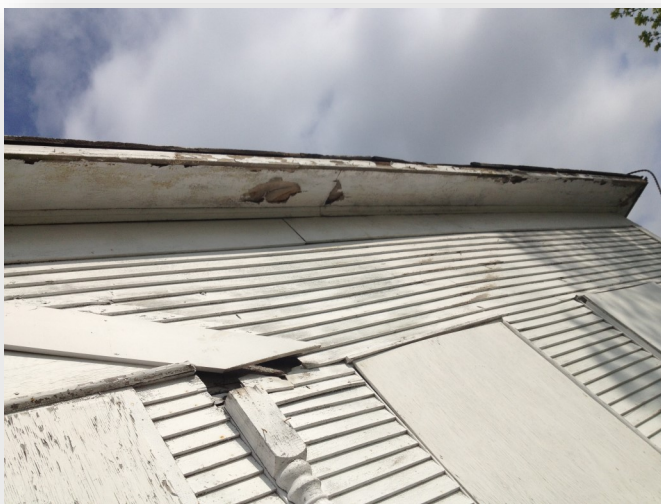
Left photo shows water-damaged soffit and board where the entry porch roof was attached. A porch half-column remains and should be preserved. The siding tends to bow out in places and the condition will not be fully known until interior surfaces are removed. Expect 20% replacement on the soffit, and 10% on the siding in Phase 2.

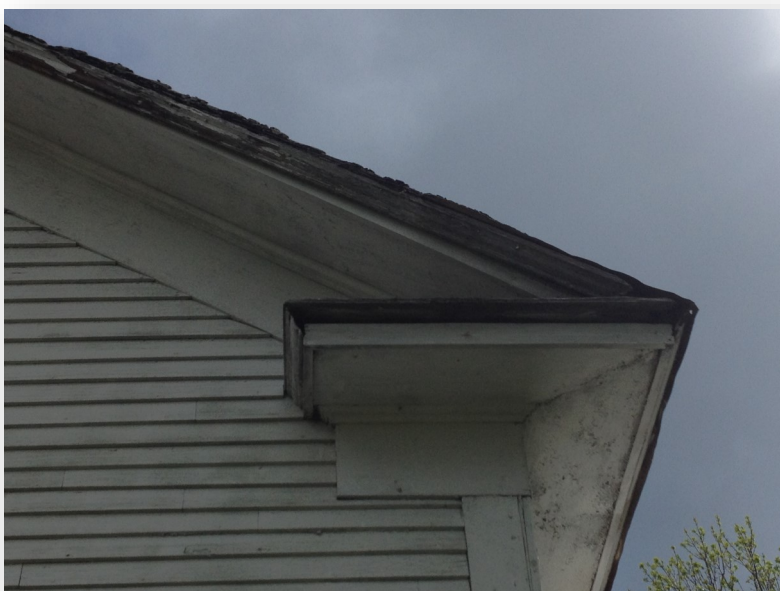
Greek Revival details such as the unadorned frieze, corner boards, and gable returns have water damage. It is important to retain these features but limited replacement will be necessary in Phase 2.

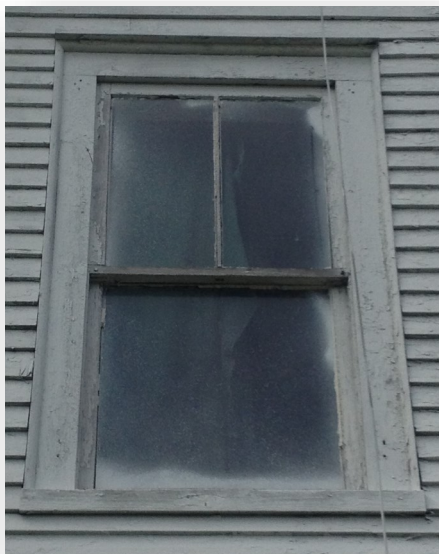
Historic 2/2/ wooden double hung sash windows were observed to be extant in the main block: visible on the second floor as shown in left photo and covered with plywood boards for security reasons on the first floor. Conditions of the windows and exterior trim appeared to be generally good. The historic main entry door also remained in place and should be retained and restored for reuse.

1) remove plywood boarding and replace with plexiglass panels installed over spacers. This will provide security, protect the windows, ventilate the building, and allow light into the building so work can begin.

1) Free, lubricate, weatherstrip, paint, and install compatible storm windows (wood, triple track, or allied invisible).

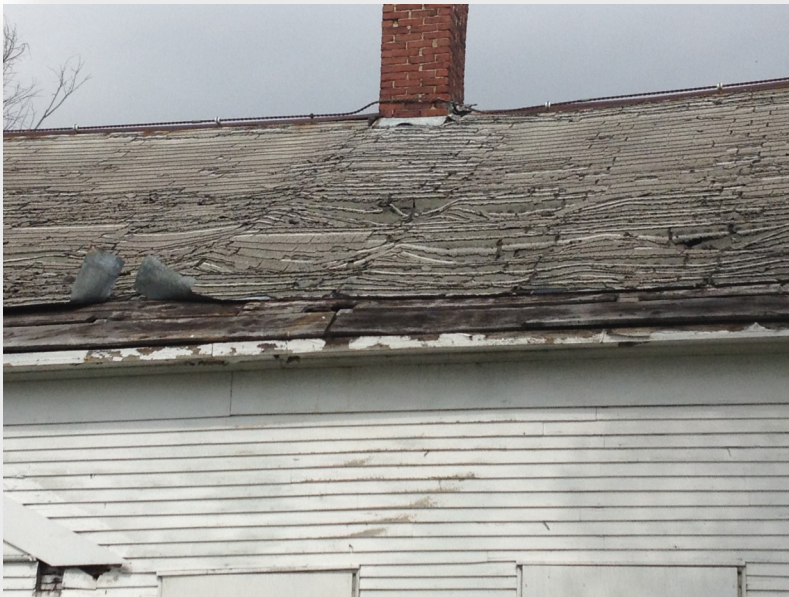
The asphalt roof shingles and plank sheathing, as evident from exterior and attic observations have failed due to long term roof leaks. Both will need to be replaced. The disposition of the existing pegged rafters which are historically significant, needs more evaluation once the building framing has been exposed. Depending on condition, the roof support system may need to be augmented with additional rafters and the plates may need to be replaced.

Photo left shows failed roof shingles and sheathing evident by the valleys between rafters. Of concern is the extend of water leaking into the exterior wall cavities. This will be known once the interior surfaces are removed.

- 1) Remove existing roof shingles and sheathing, brace and reinforce rafters as required, install wood strapping, install new temporary steel roof.  
Allow \$18,000.

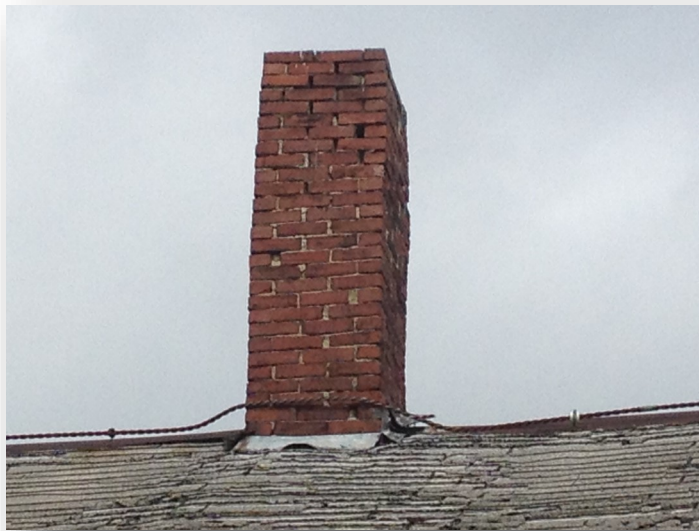
A single brick chimney extends from the basement and penetrates the roof just north of center. Loose bricks and missing mortar above the roof line will need remediation

- 1) Repoint brick chimney to prevent further deterioration when the roof is being replaced.  
Allow \$ 500

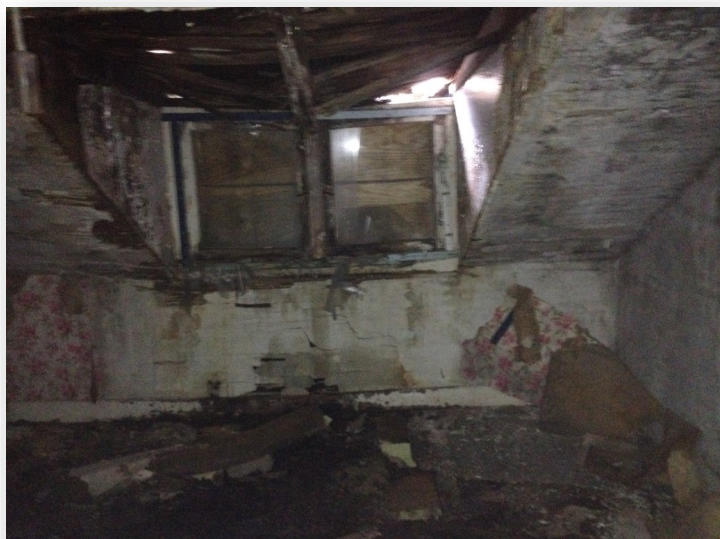
Left photo is upstairs bedroom showing collapsed roof and soaked interior. The dormer and all interior surfaces should be removed in Phase 1.

- 1) Complete demolition of interior spaces back to framing using list on page 15 as a guide:  
Allow \$ 7,500

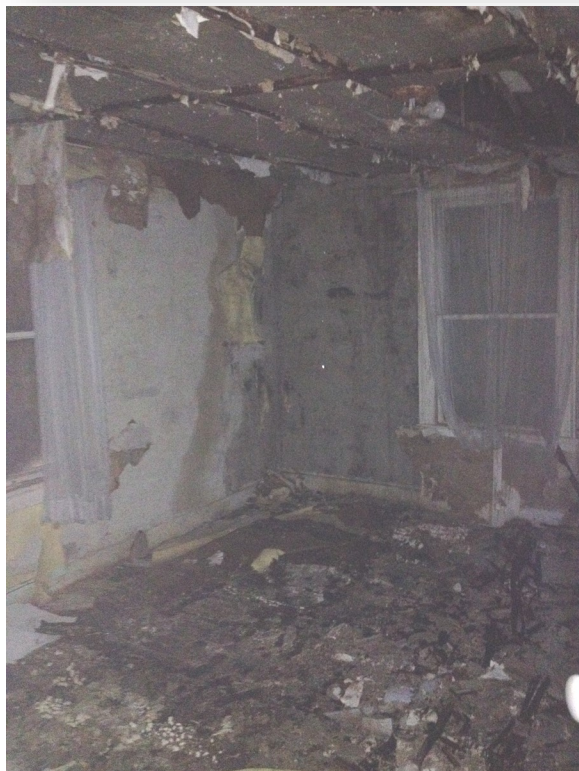
Extant historic windows but ruined interior walls, ceiling, and floors. The site and exterior are more important historically than the building interior which is very simple. Discussion should take place about rebuilding the interior with the same, or similar configuration allowing for ADA as needed.

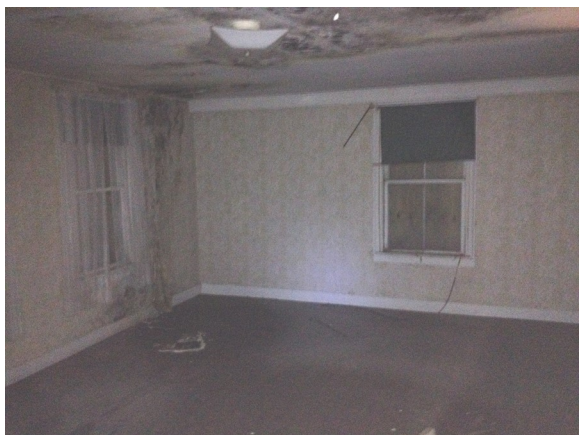
Shown left is the livingroom—not as damaged but still requiring removal of surfaces. Flooring could possibly be saved in this location. 2/2/ windows are important features and should be retained.
