THE GENERAL STANNARD HOUSE

MILTON, VERMONT

BY: The Office of Martin S. Tierney, A.I.A. 82 Church Street Burlington, Vermont

DATE: 23 November 1988

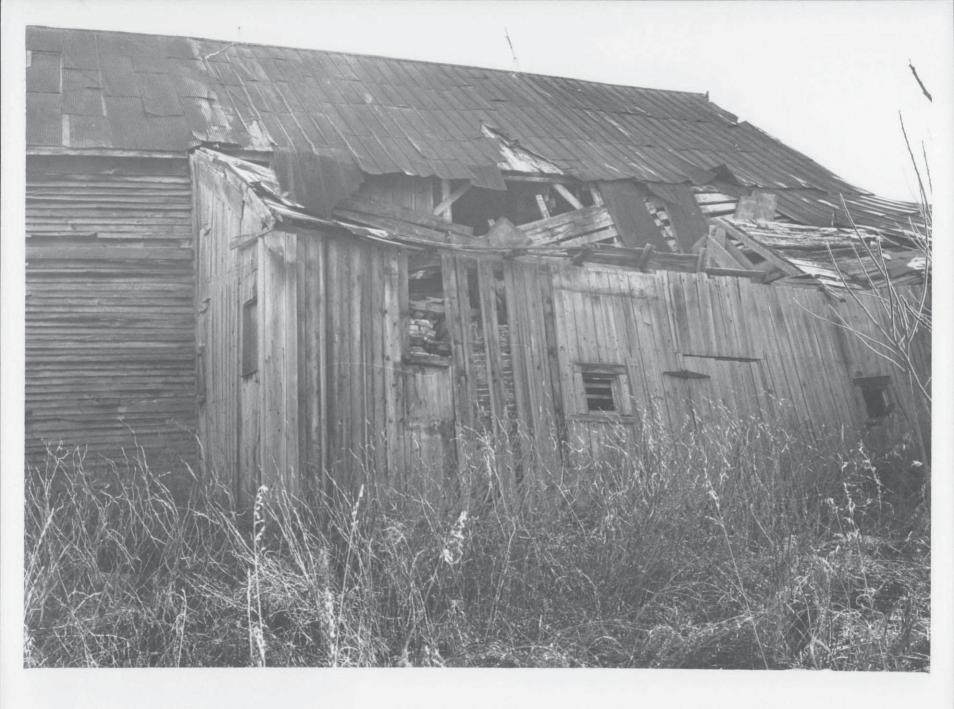
Vt. Div. for Historic Preservation Chittenden County Milton 12/88 Stannard House & Barn E 88-A-318 Nancy Boone

The east side of the building has some deflection in it. Since the foundation seems to be locally good, this sagging could be indicative of some sill compression. The sill, however, is completely covered with brick in the basement and is unavailable for examination. The entry porch which seems to be an 1890's addition is in poor condition and should be removed. All of the basement windows in the building are rotten and should be replaced. The roof on the east side seems to be in a great deal of distress. Water has considerably erroded the grade in the immediate area of the building and a gutter system should be utilized.

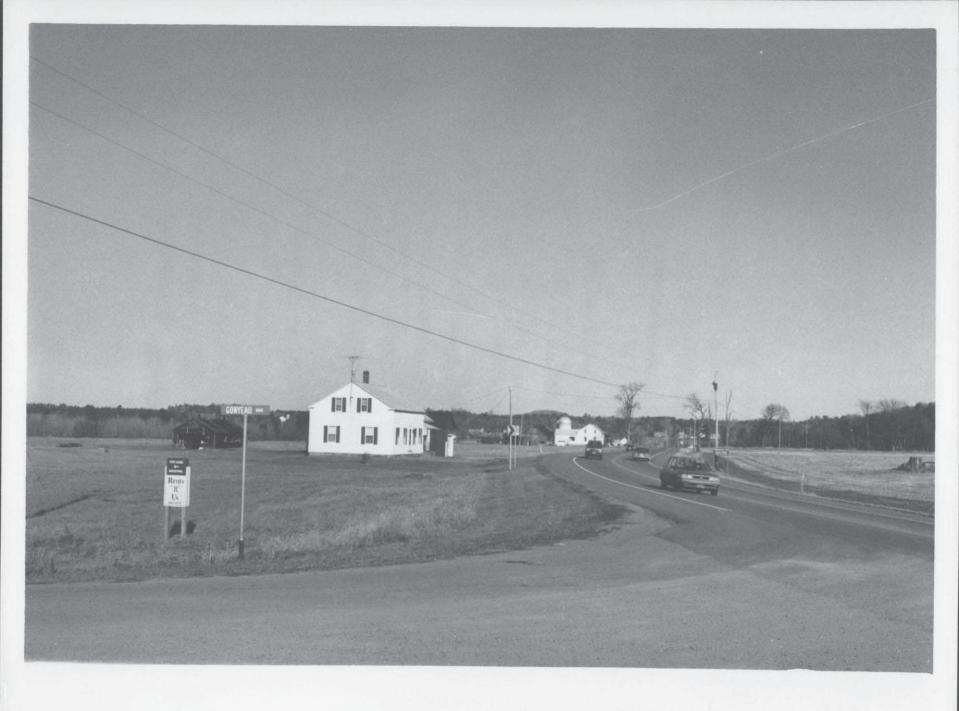
Vt. Div. for Historic Preservation Chittenden County Milton 12/88 Stannard House & Barn N 88-A-318 Nancy Boone

The north side of the building seems to be relatively plumb and has no outstanding problems of note.
